# Situation Photo Log

Thursday, December 6, 2012

Kalamazoo River / Enbridge Spill

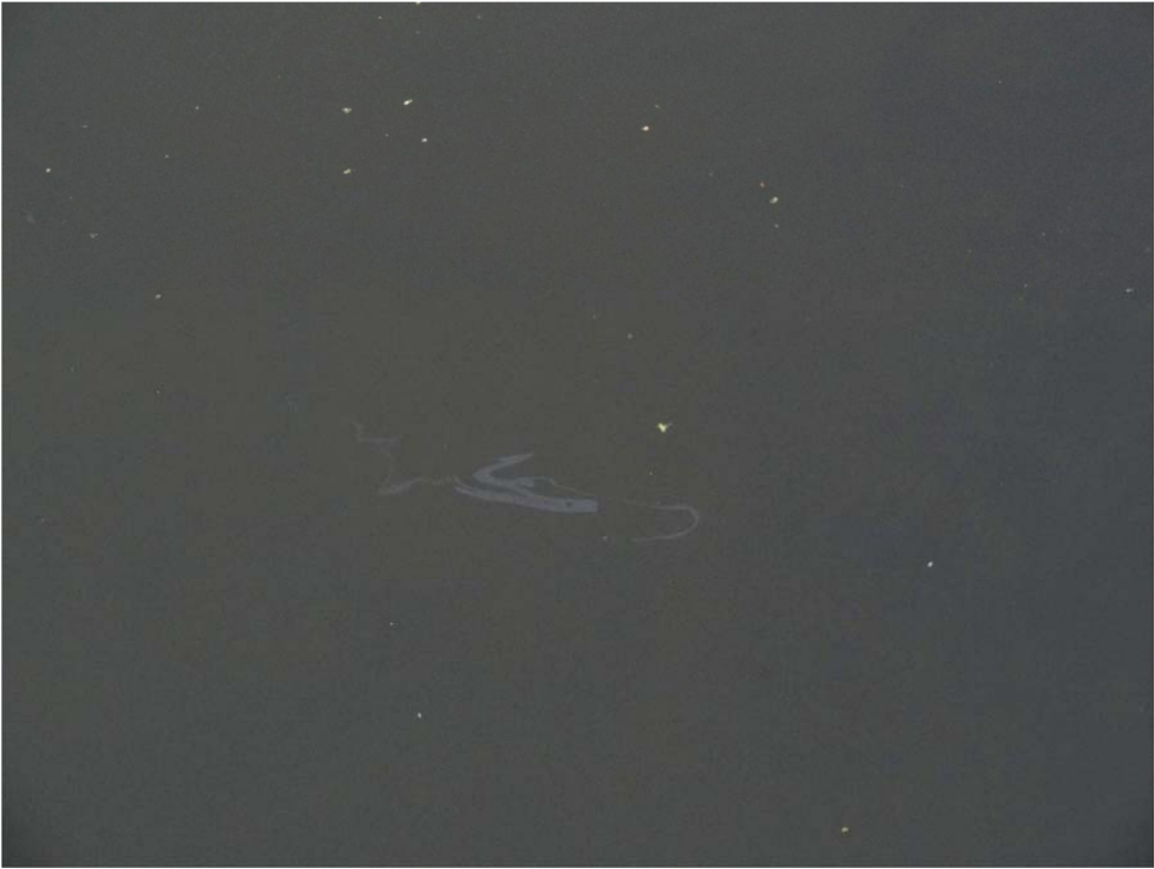
1. MP5.50 LDB sheen and tar globs observed.

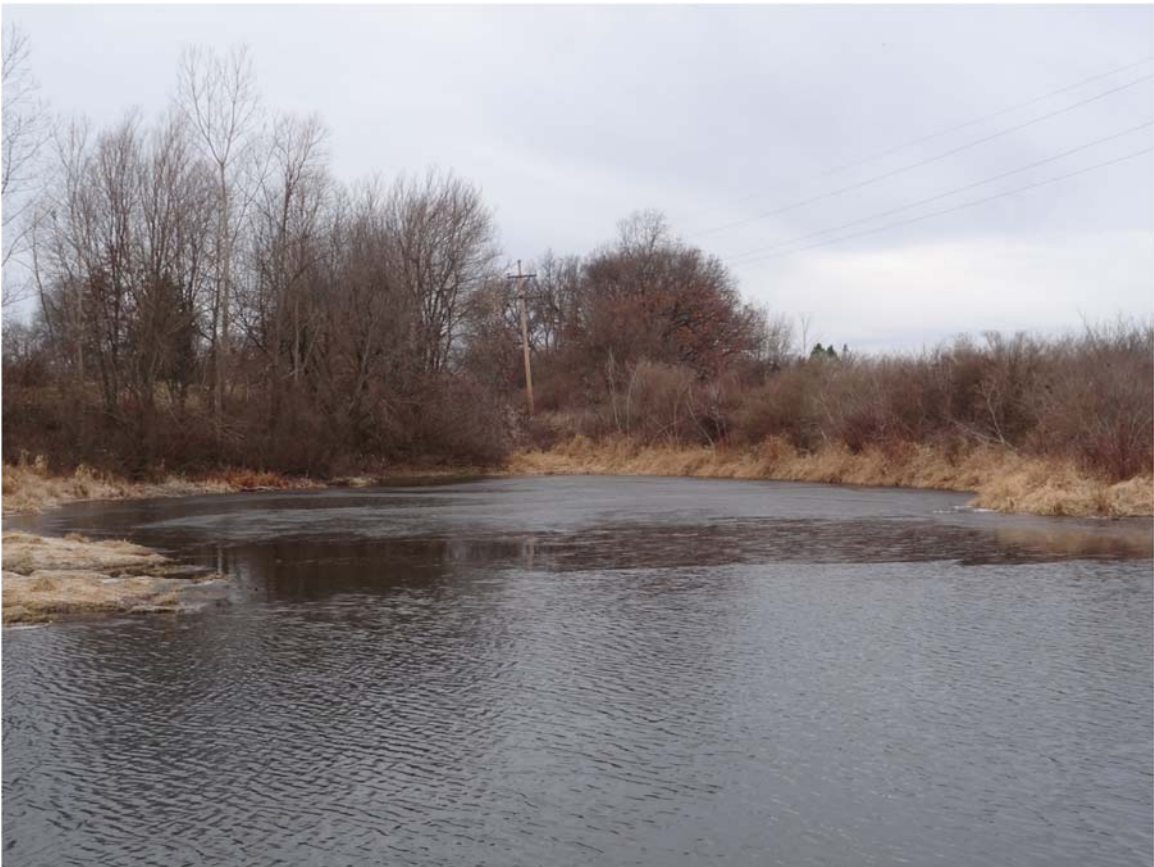
2. MP5.63 LDB observed ice forming.

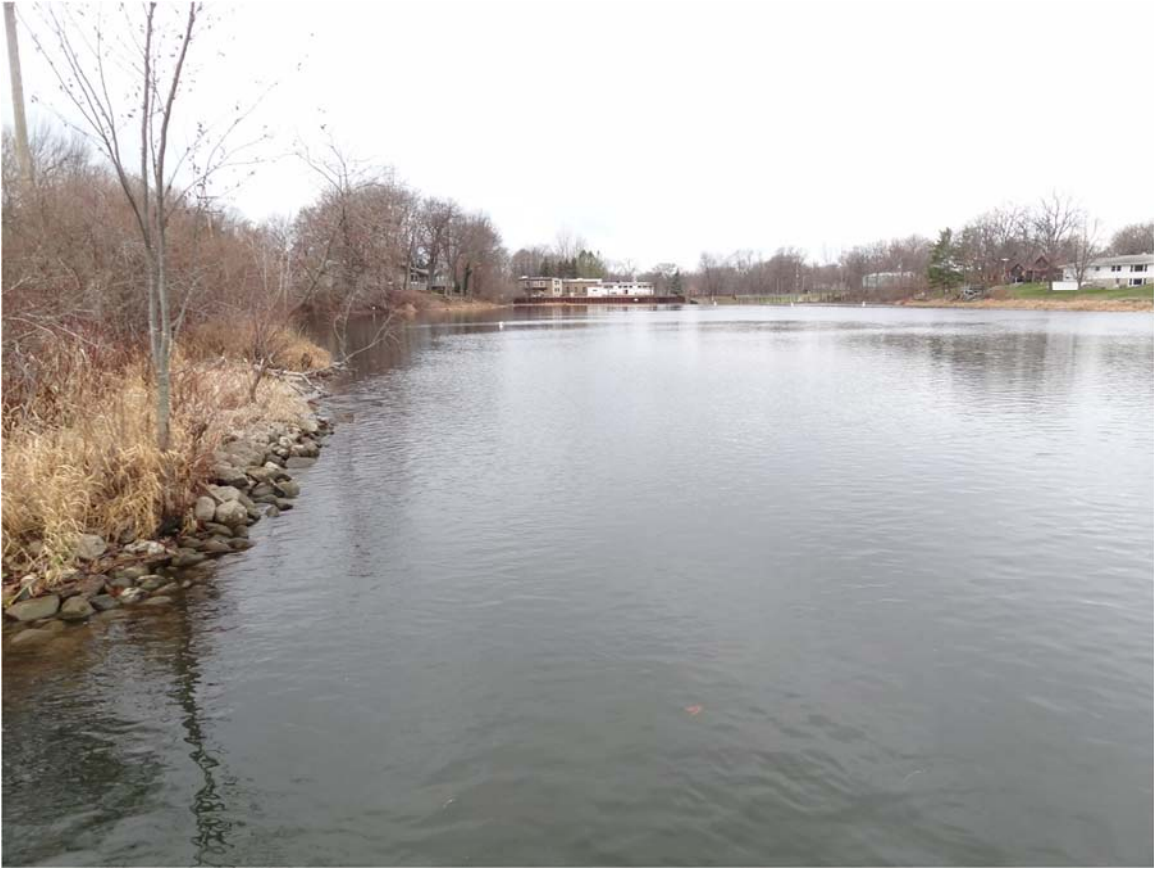
3. MP5.63 LDB area where sheen and tar globs were observed.

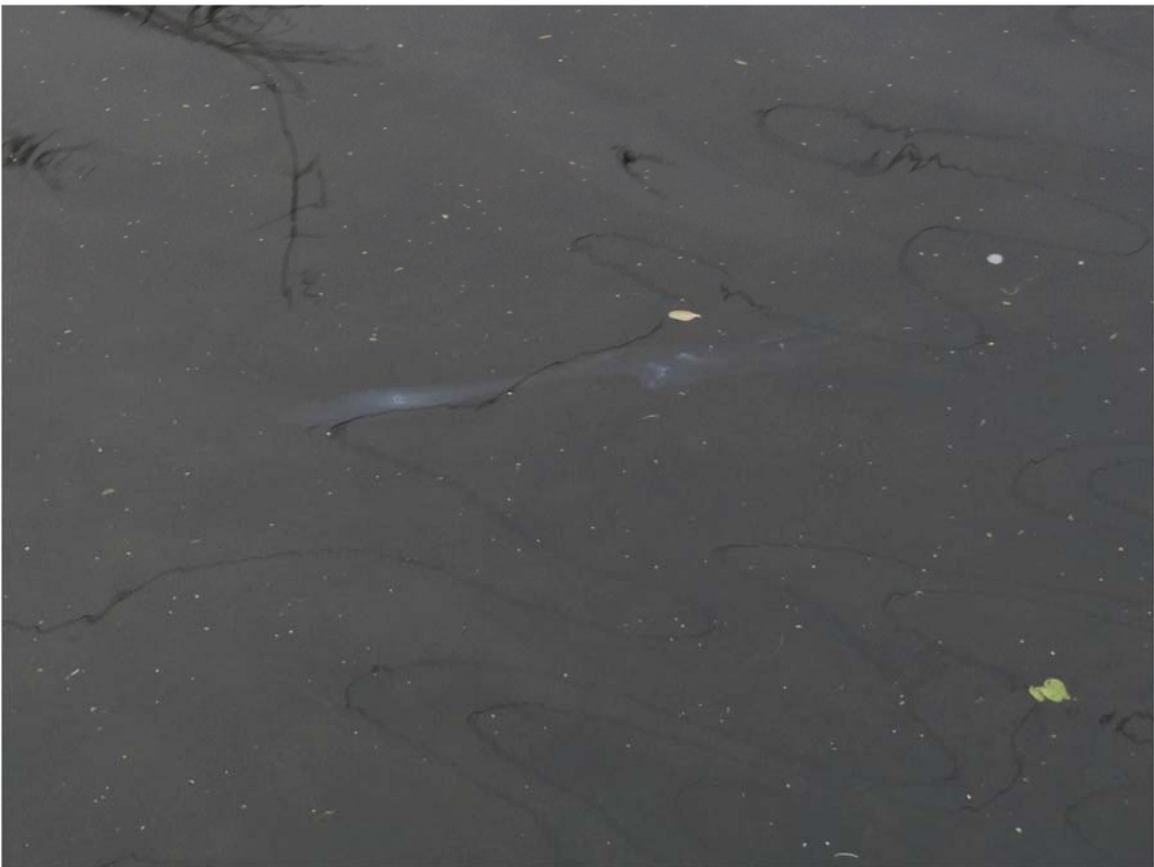
4. MP5.63 LDB sheen and tar globs observed.

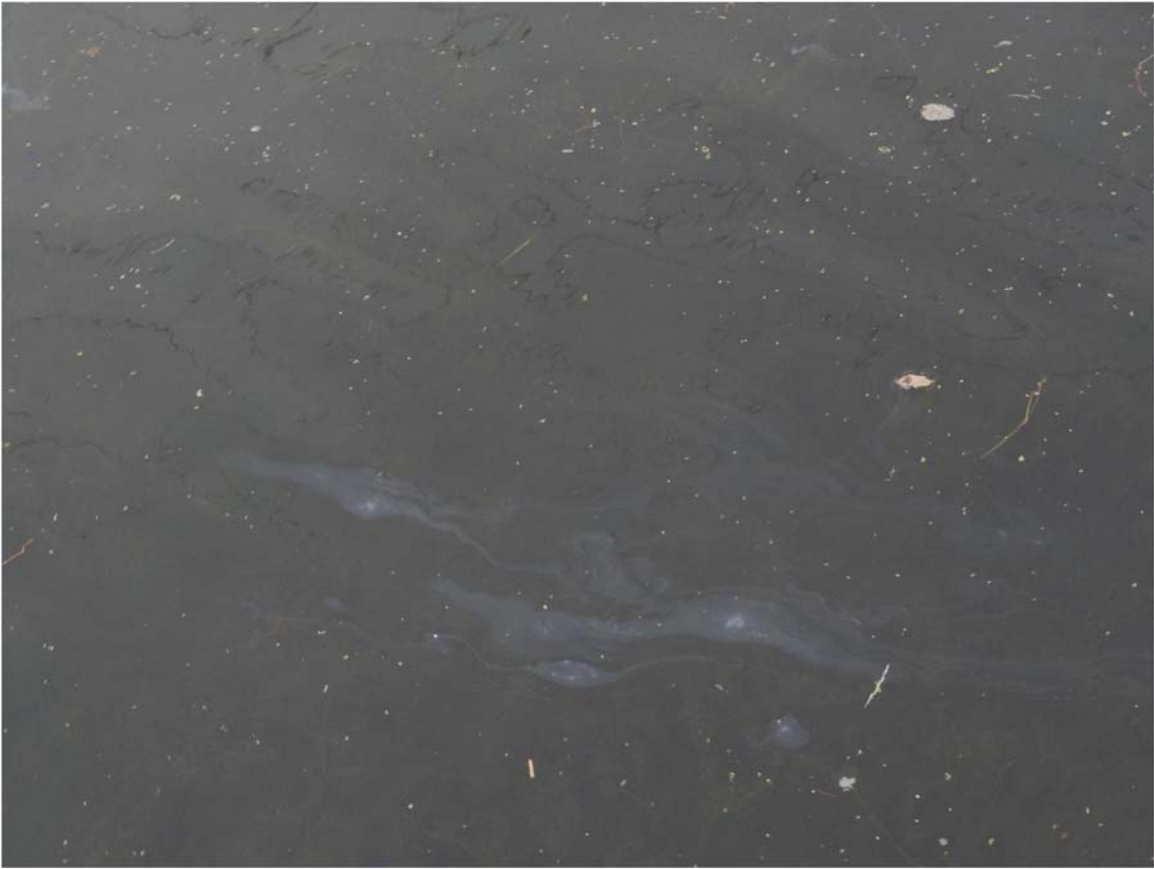
5. MP5.63 LDB sheen and tar globs observed.

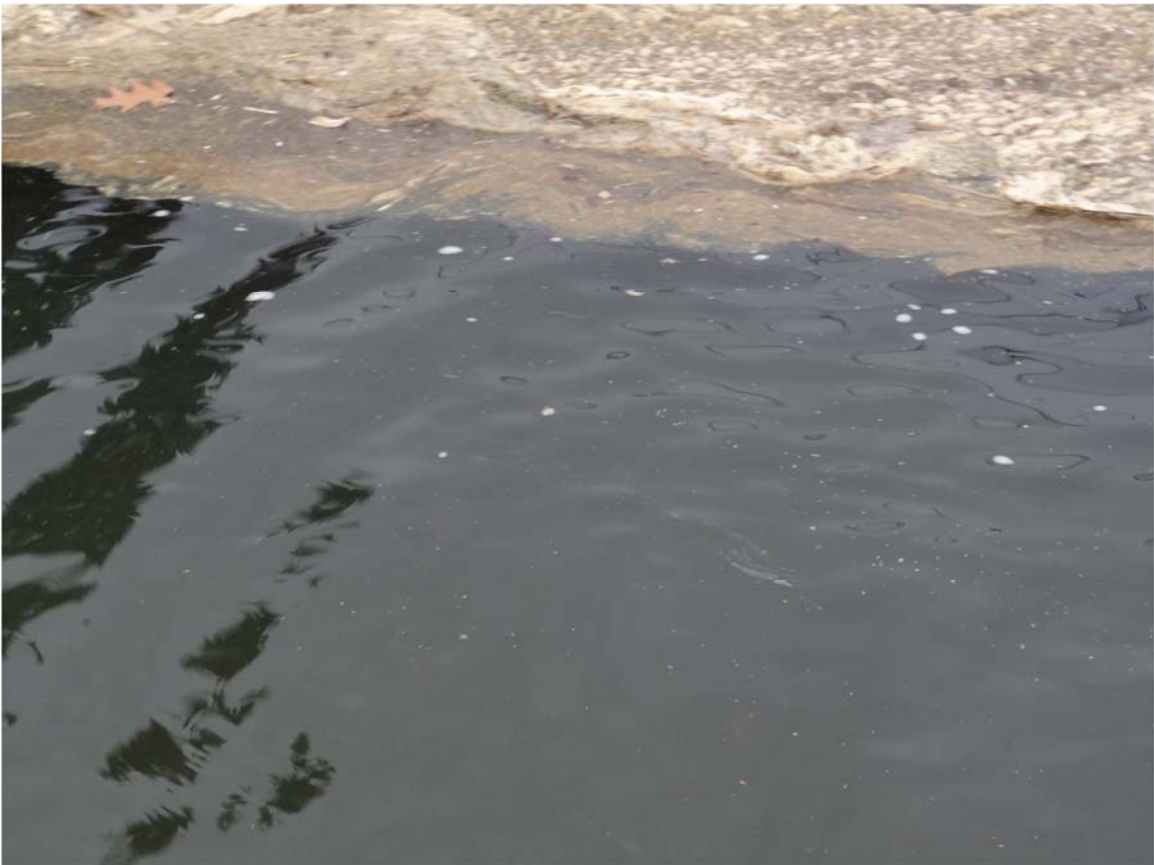
6. Ceresco Dam control point boom observed sheen and tar globs collecting along the boom.

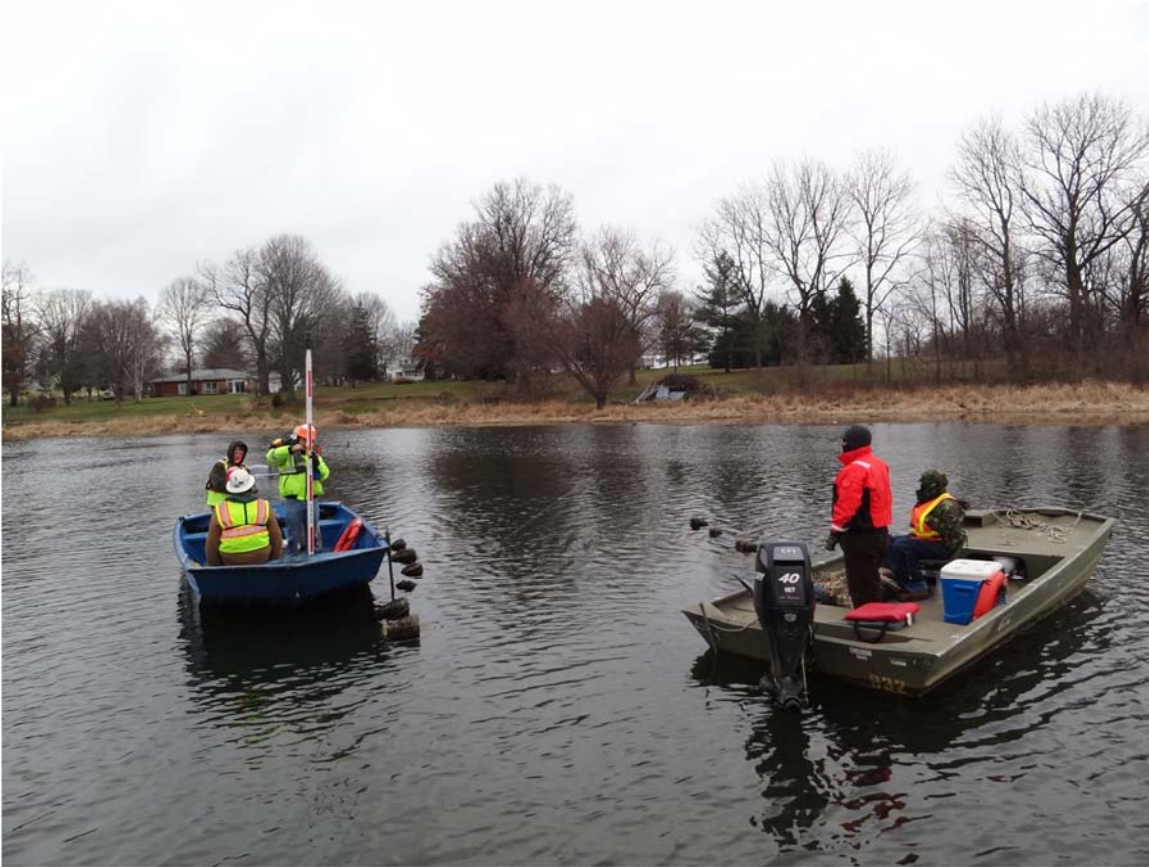
7. Ceresco Dam observed a bathymetry team operating.

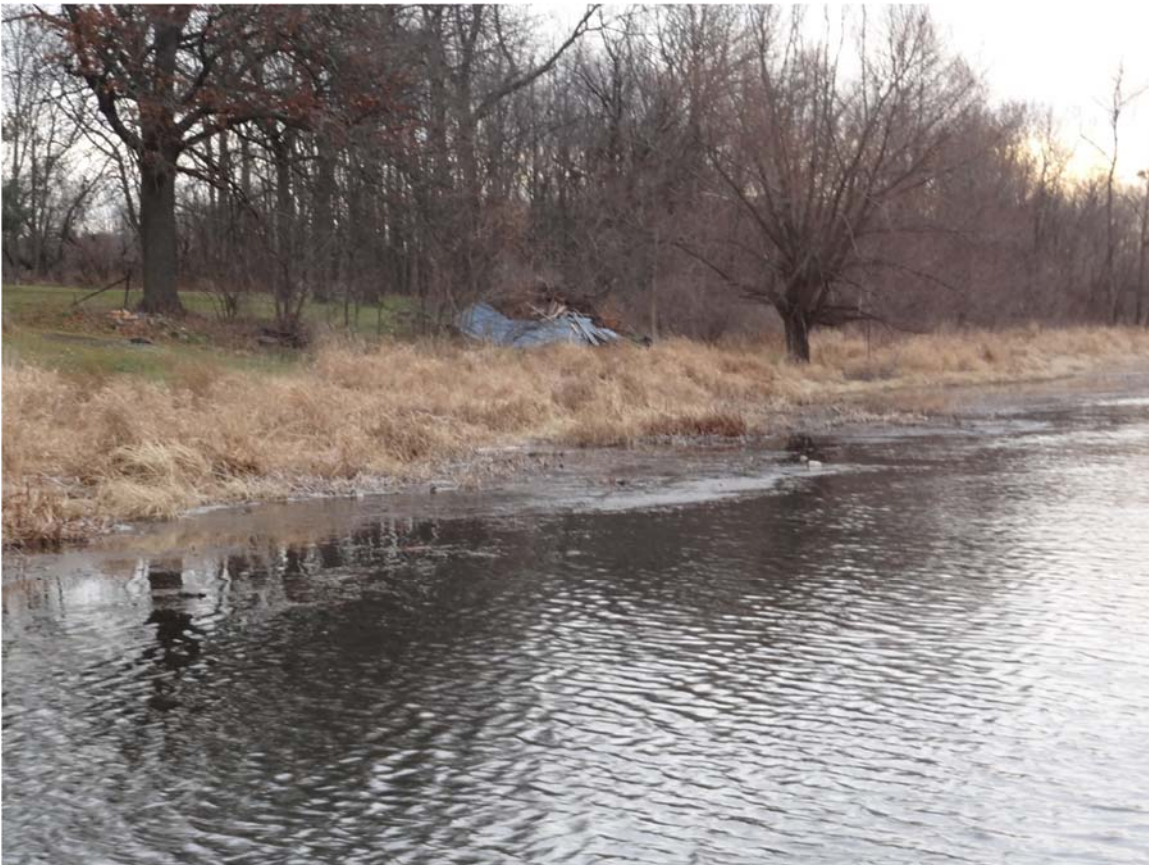
8. MP5.70 RDB observed ice forming along the bank.

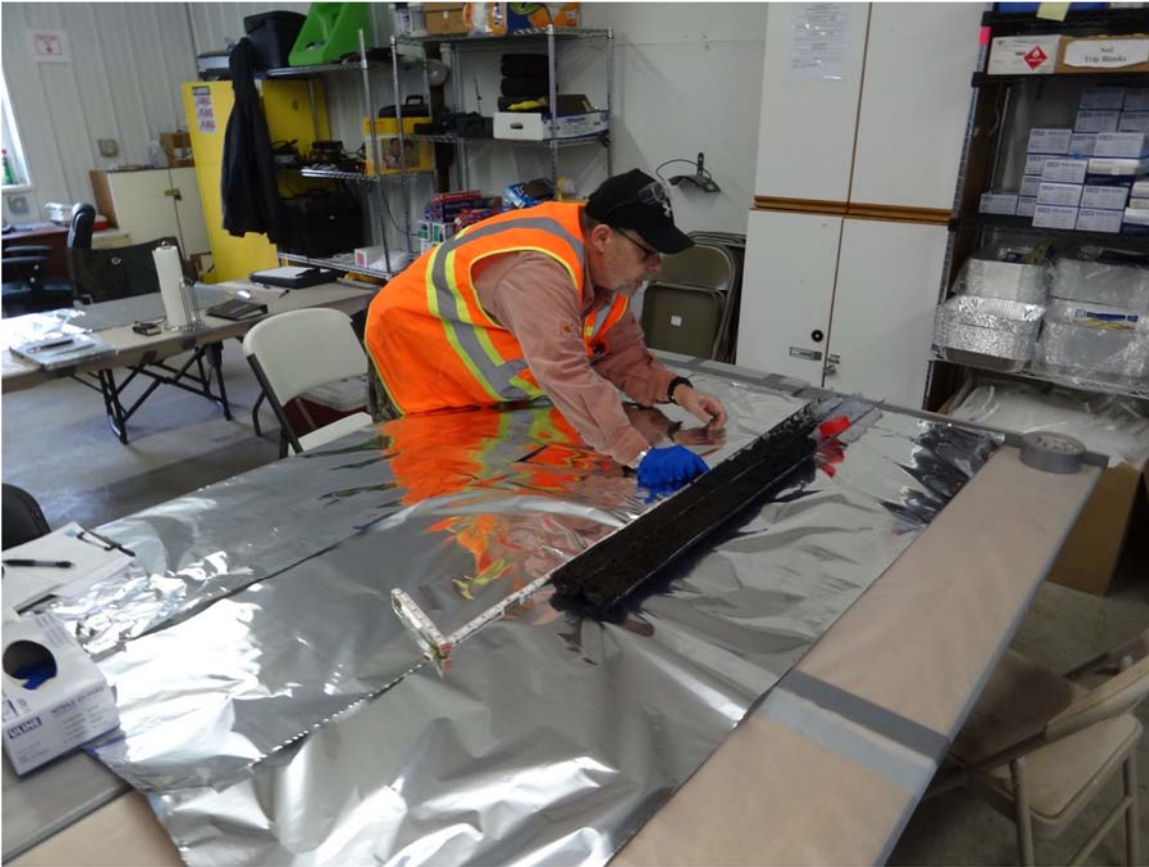
9. Core logging operations.

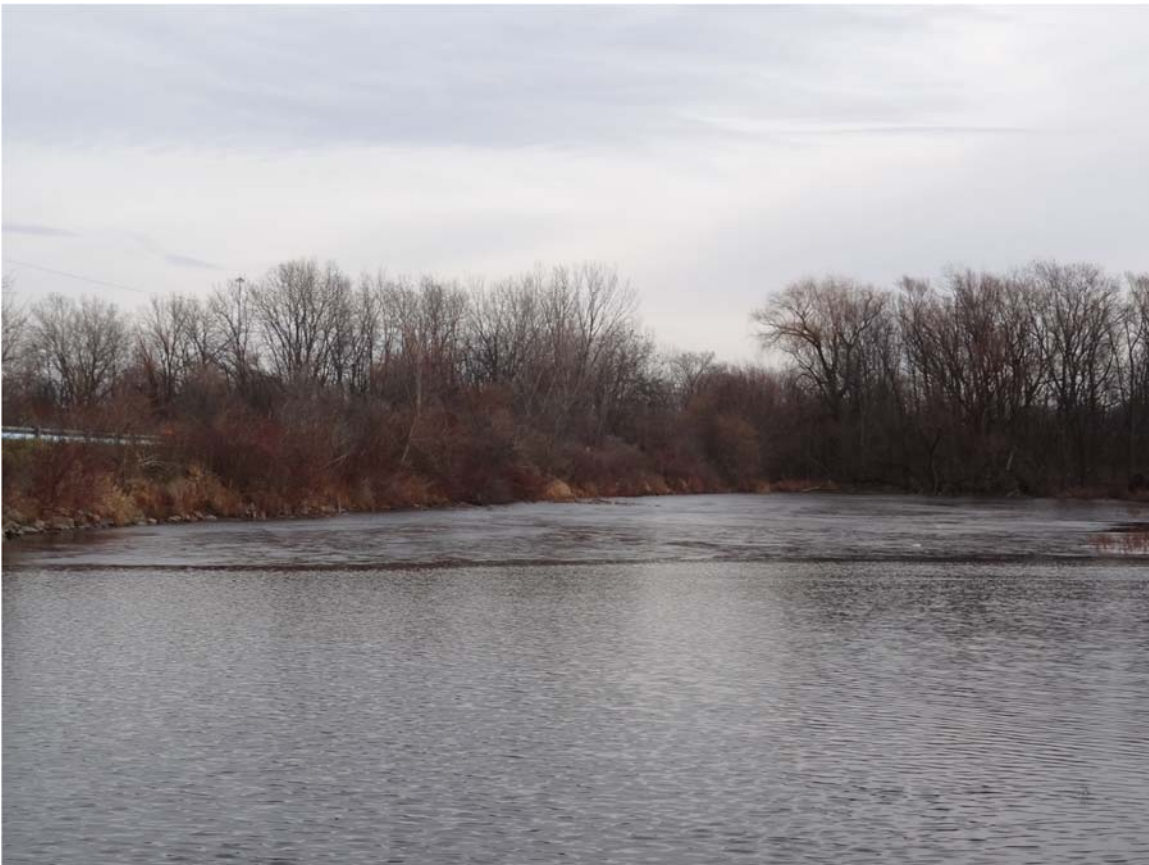
10. MP15.25 South Mill Pond observed ice forming.

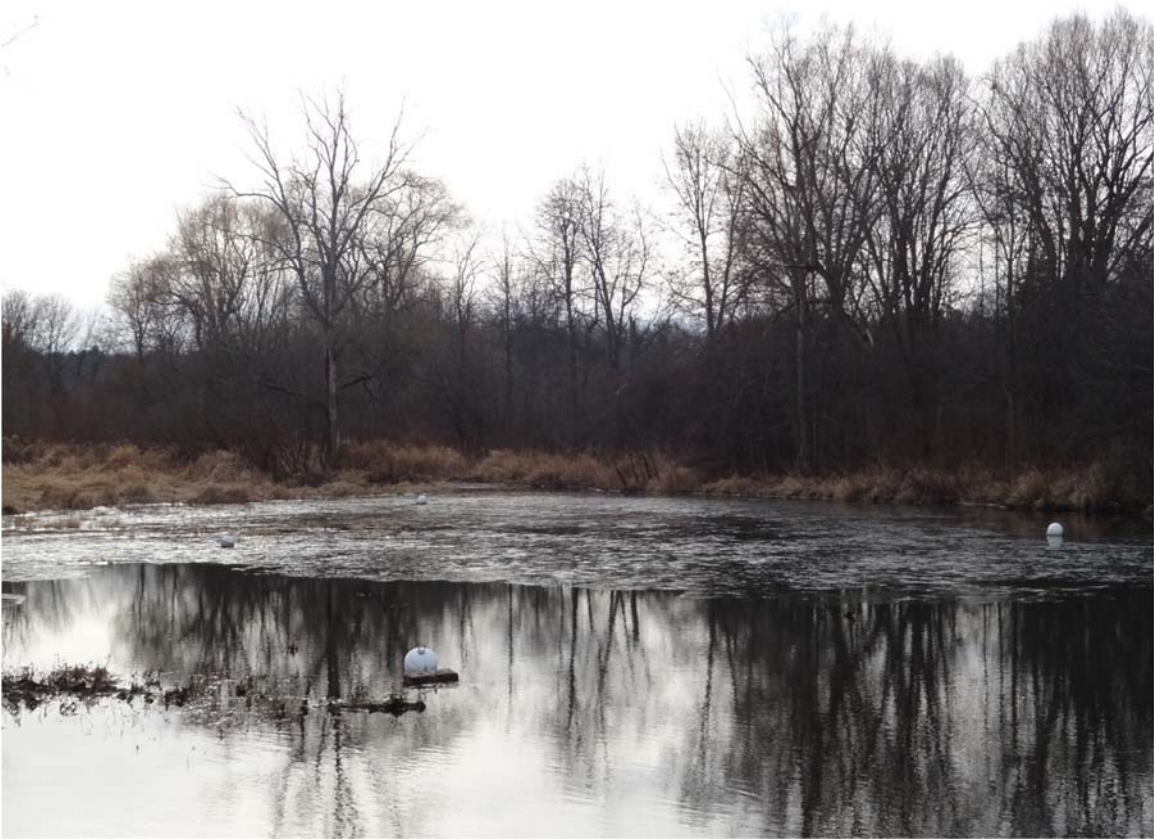
**11. MP10.5 L1 Sediment Trap observed ice forming.**

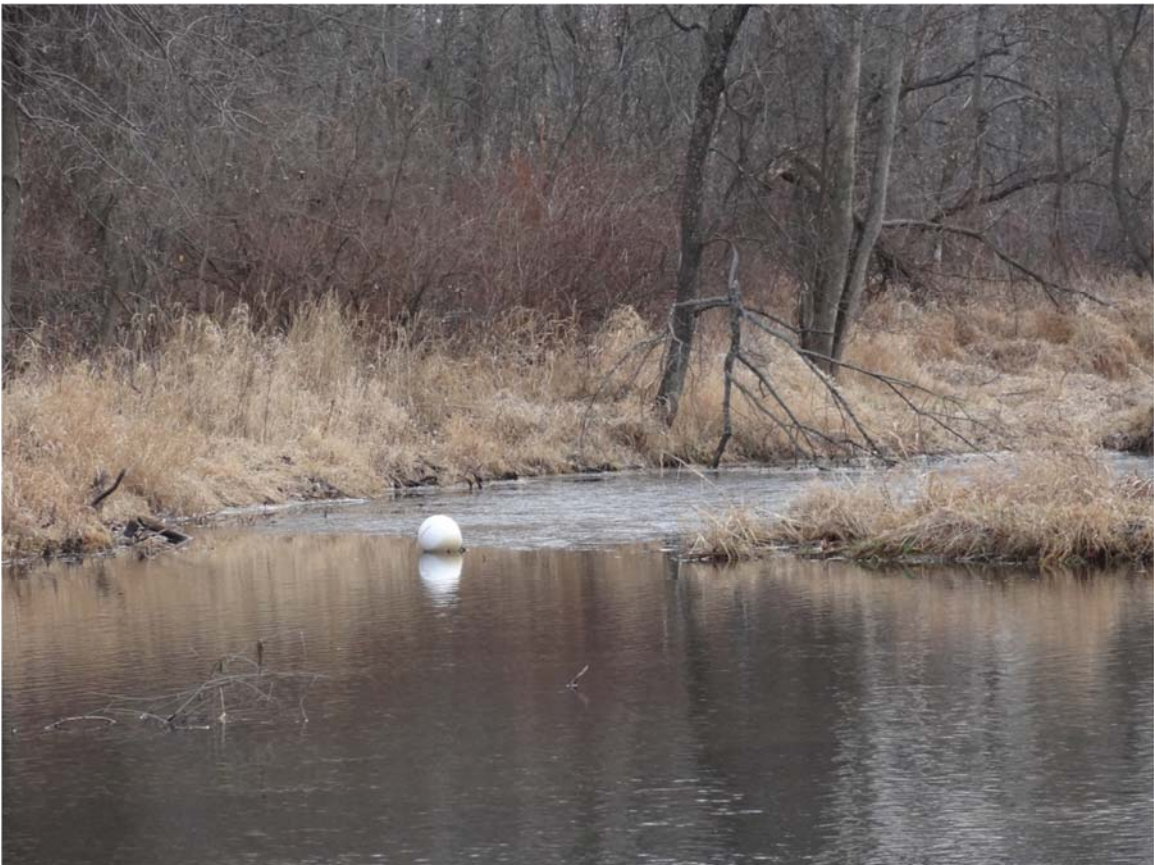
**12. MP10.4 RDB Sediment Trap observed ice forming.**

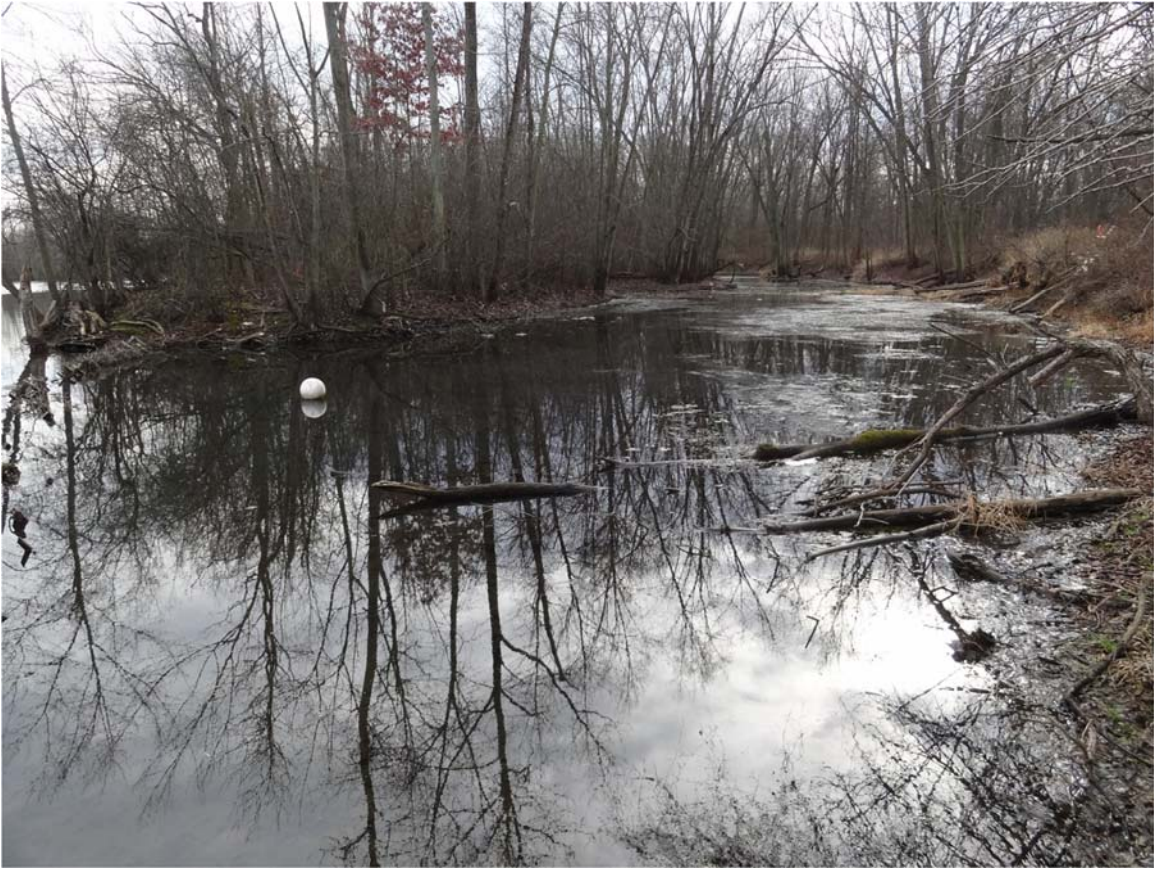
13. MP19.25 LDB Sediment Trap observed ice forming.

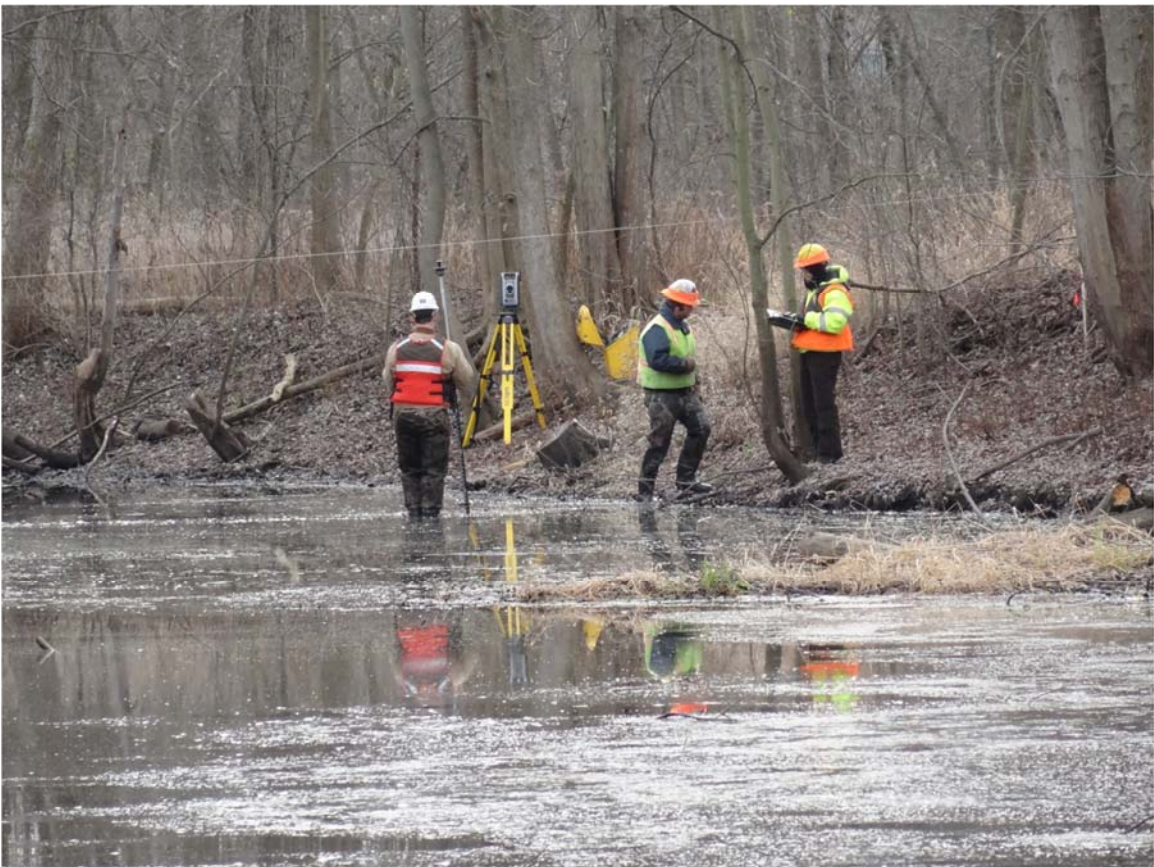
14. MP19.25 Sediment trap observed bathymetry work.

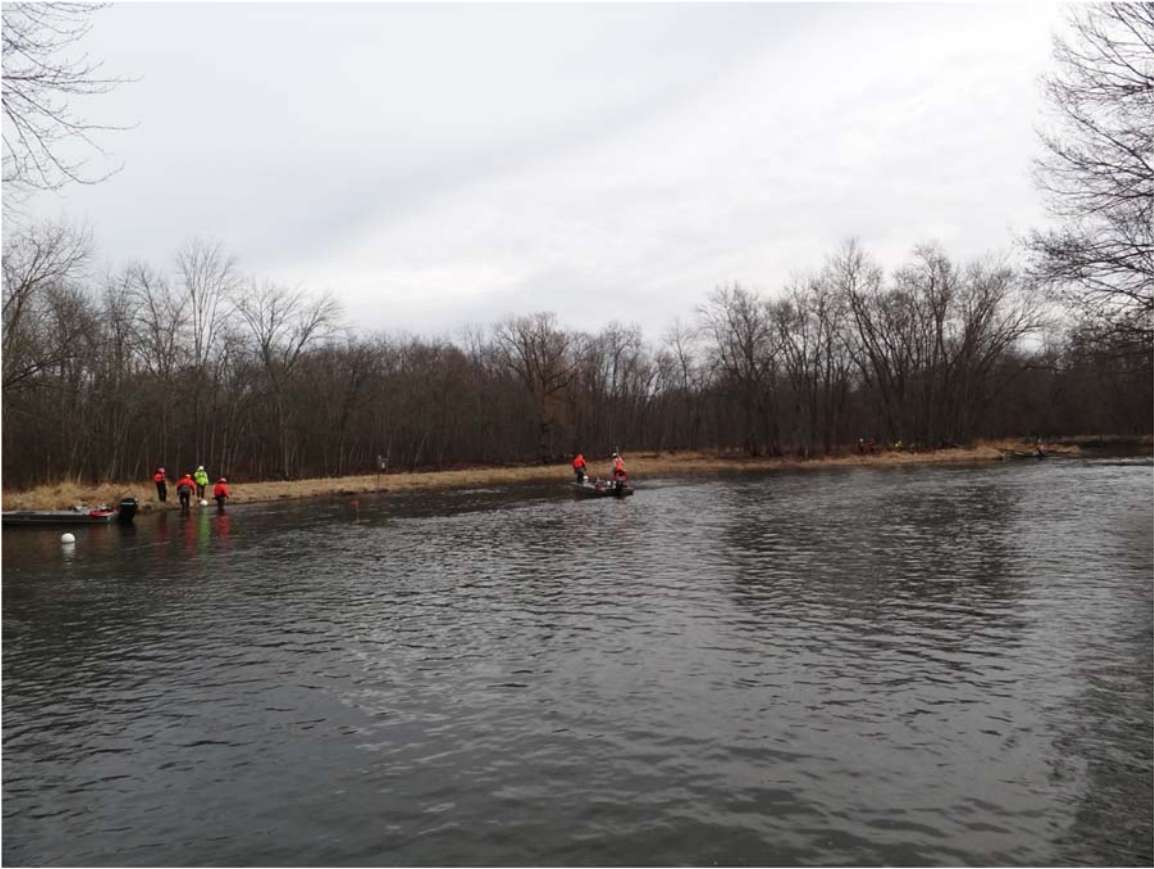
15. MP26.0 Sediment Trap observed bathymetry teams operating.

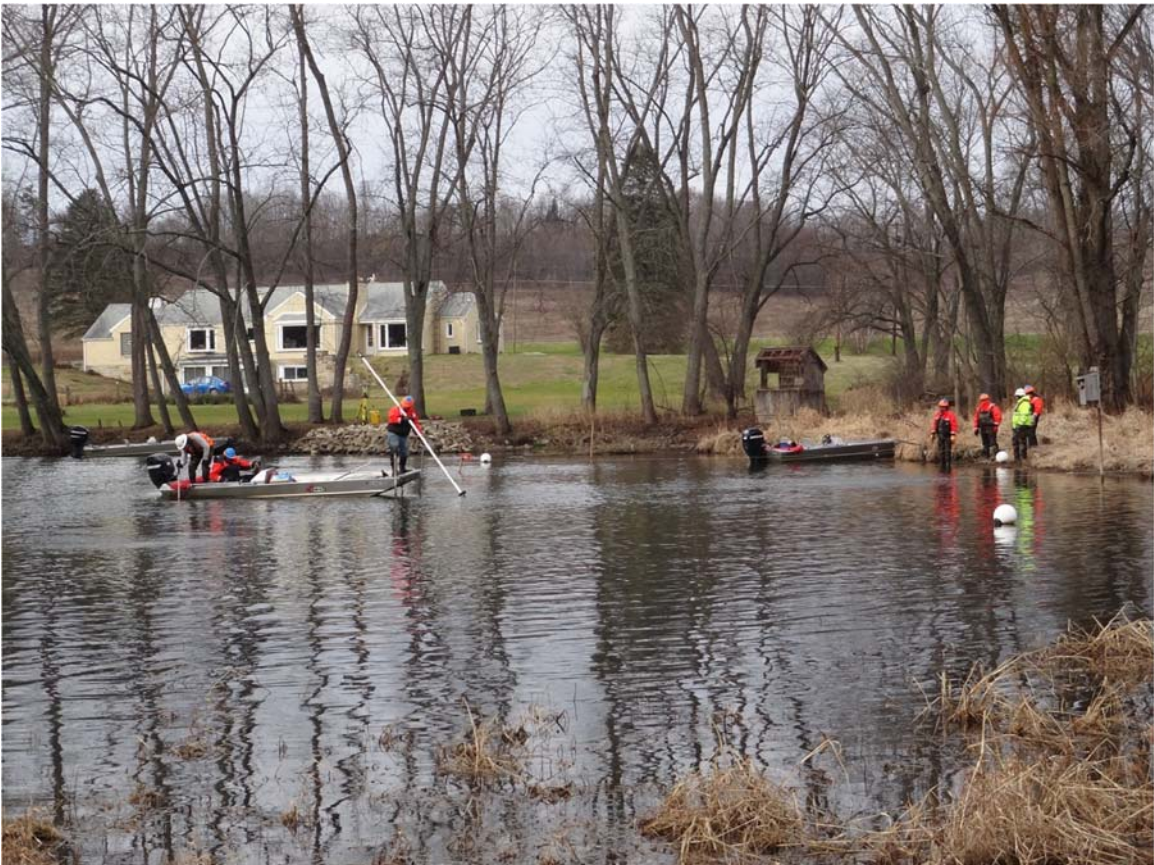
16. MP26.0 Sediment Trap observed bathymetry teams operating.

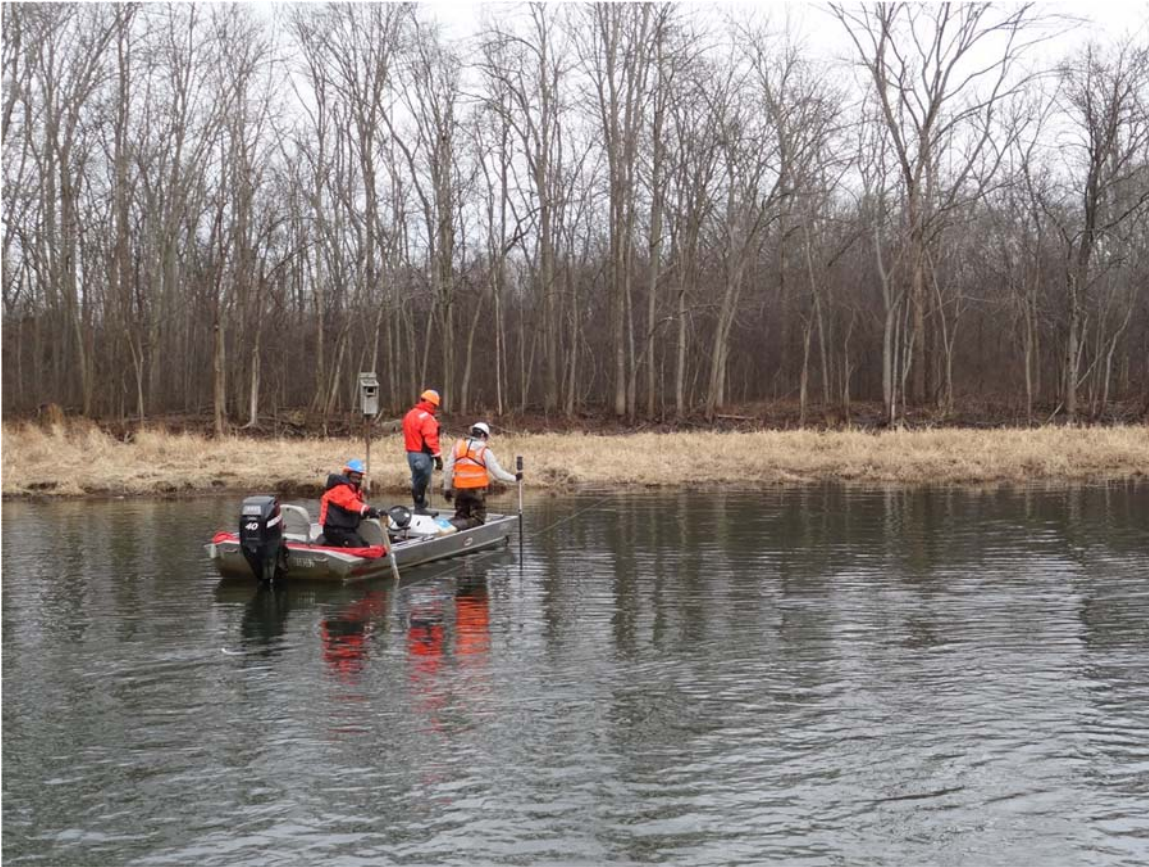
17. MP26.0 Sediment Trap observed bathymetry teams operating.

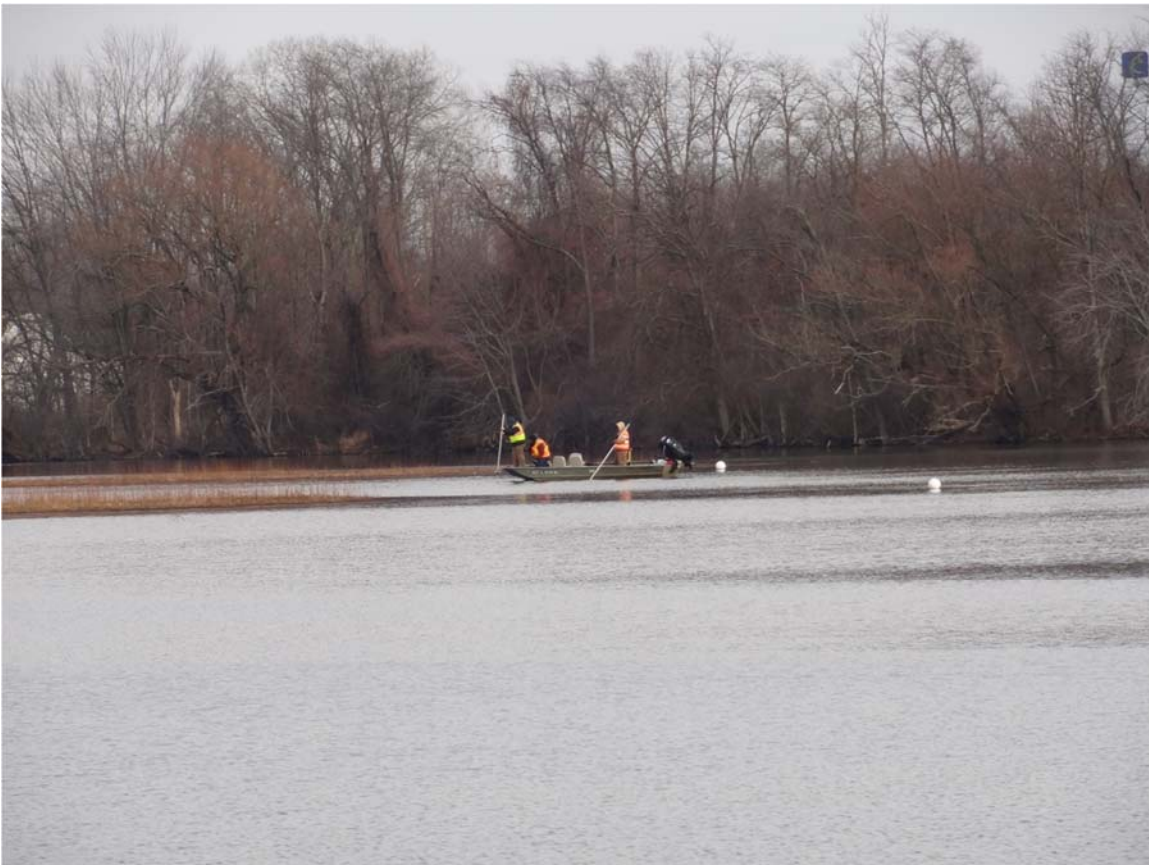
18. Morrow Lake Delta observed a poling team.

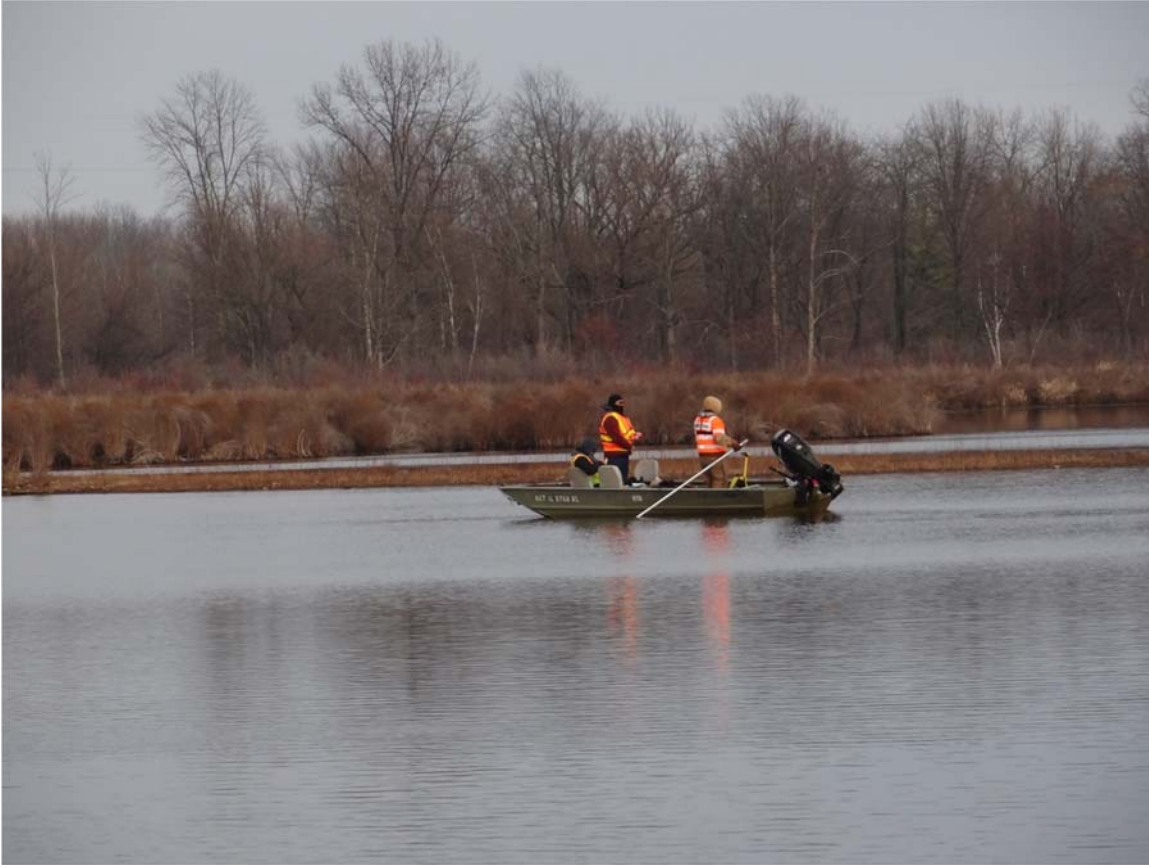
**19. Morrow Lake Delta observed a poling team.**

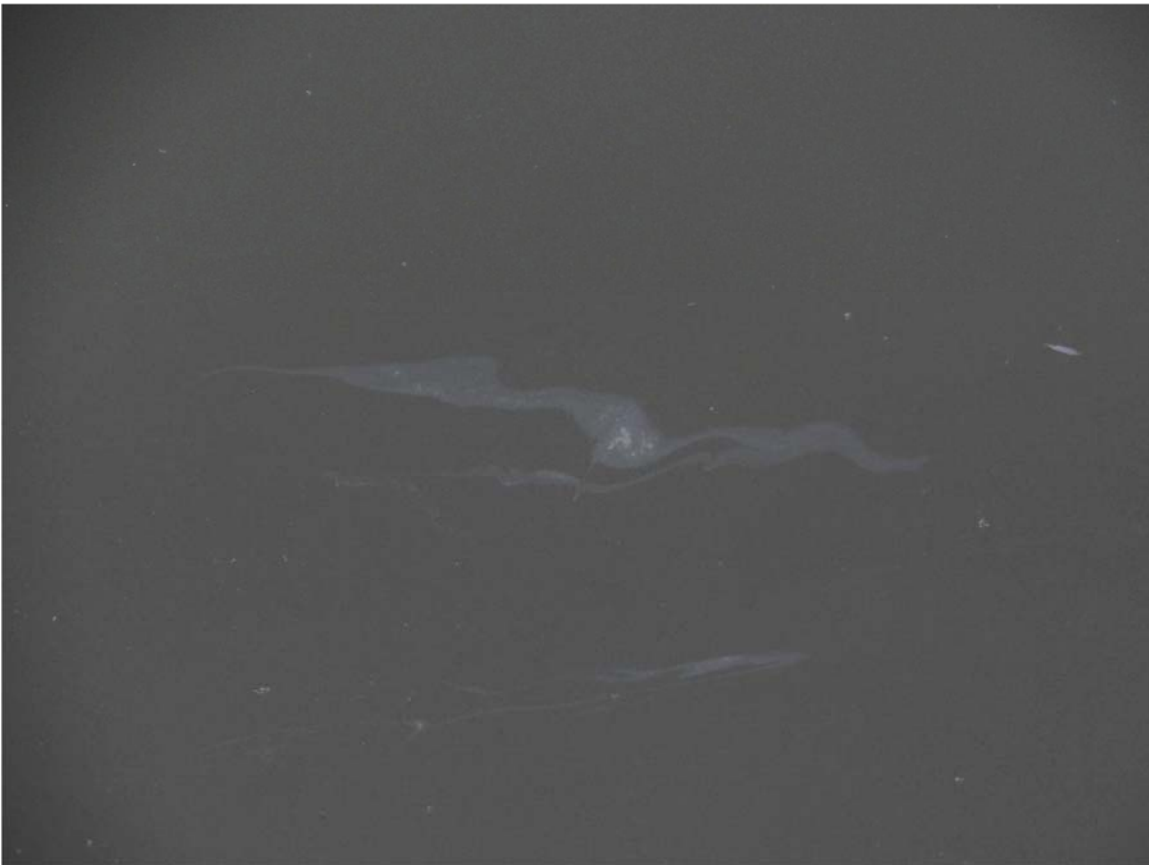
**20. Morrow Lake Delta observed sheen and tar globs in the vicinity of the poling team.**
